Viewpoint Estate Stage F5 Huntly

Earthworks Supervision Report for DPJ Civil

Report 23C 0046 F5
July, 2023

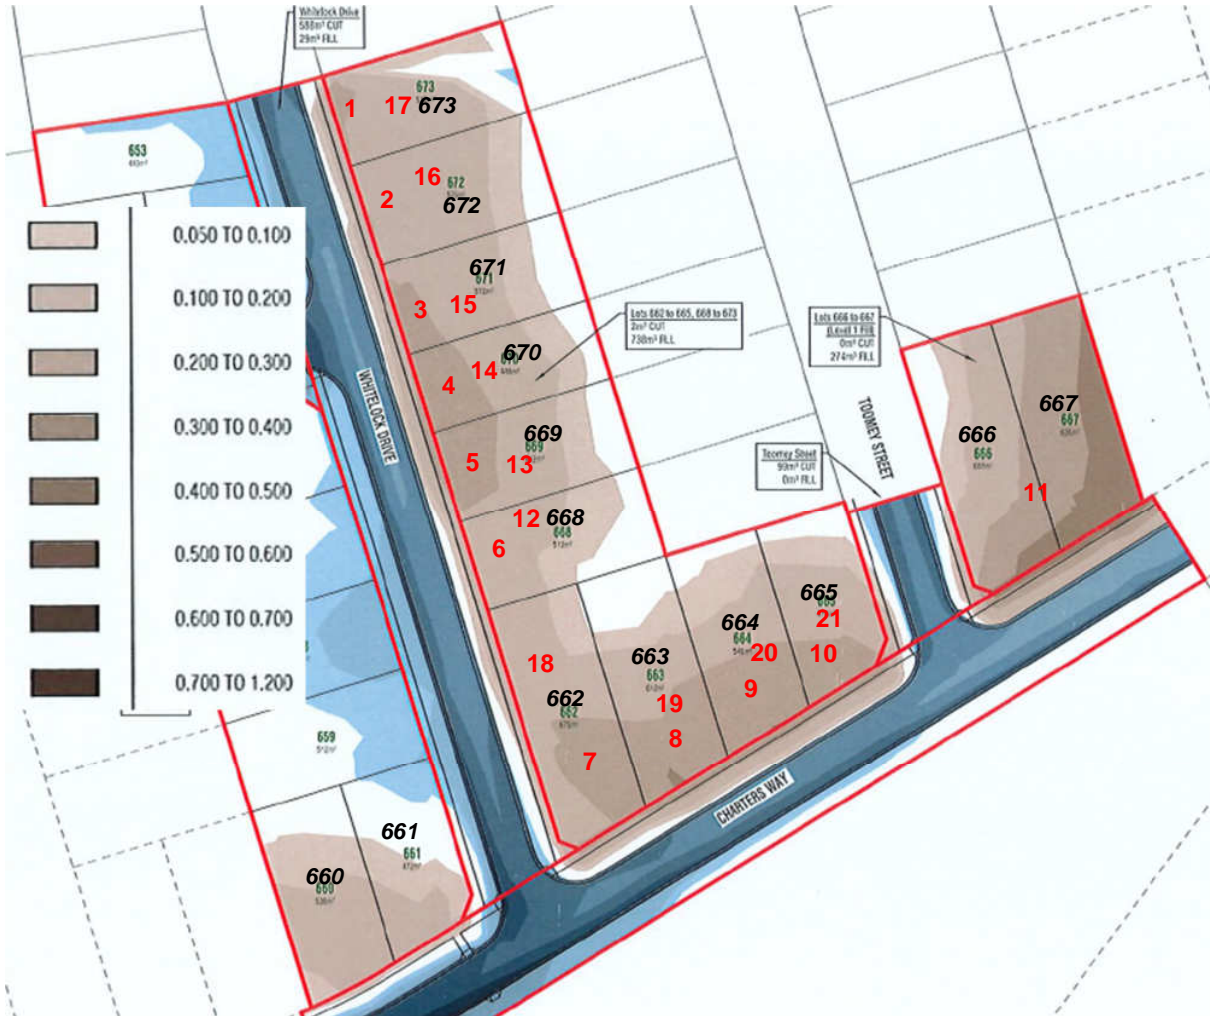
Fig 1: Site Plan

The depth of fill across the site varied from none to around 400mm at its deepest with the approximate locations shown on the attached site plan. It is noted that sites with 300mm or less were not included in the controlled fill operations.

Level 1 inspection and testing was undertaken by a geotechnician from GTS who nominated the timing and location of the in-situ density tests. The approximate location of each test is recorded on the test reports and attached fill plan.
